Subject: Department of Natural Resources Washington Geological Survey,
School Seismic Safety Assessment Project, Contract No. AE 410 -
Seismic Evaluation for **Thorp School District**

School Buildings Evaluated in the Thorp School District

1.1 Building Description

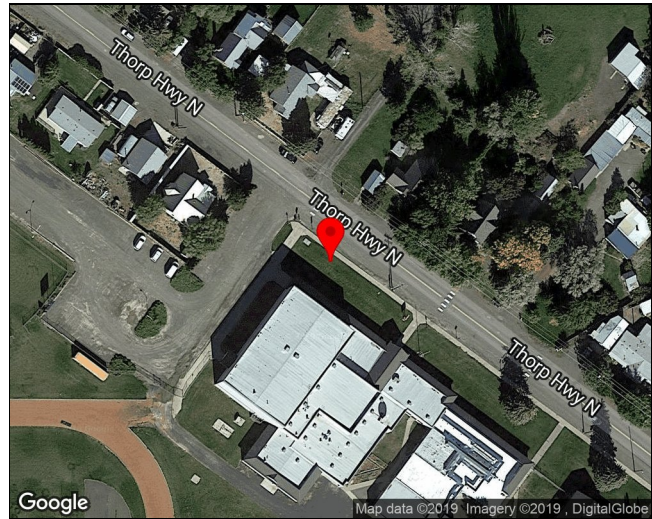
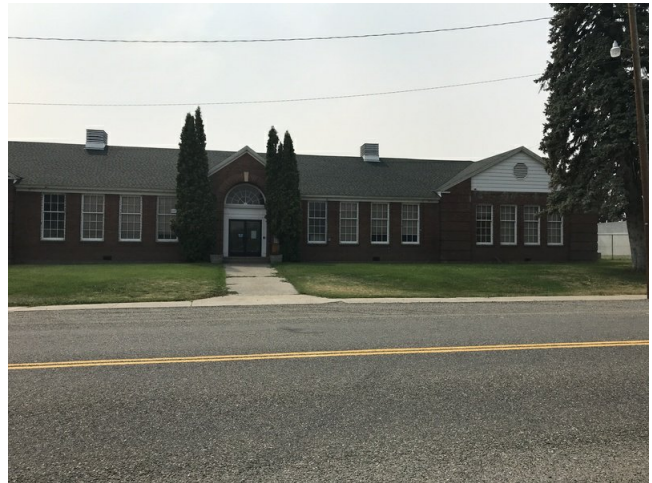
Constructed in the mid 1930s, the Thorp Middle School building is a one-story brick structure (approximate dimensions are 100 ft x 150 ft) with mechanical and storage in a small basement level space. The building has a wood frame floor with a crawl space below. The wood roof trusses were exposed in the gym. Interior faces of walls are "sheathed" in lath and plaster, both the interior face of the exterior masonry walls and each side of interior walls. The ceiling panels are fastened directly to the underside of the wood roof trusses over the classrooms. The building shares the site with the newer 1950 Thorp Elementary School space and the 1991 Thorp High School addition to the 1950 building.

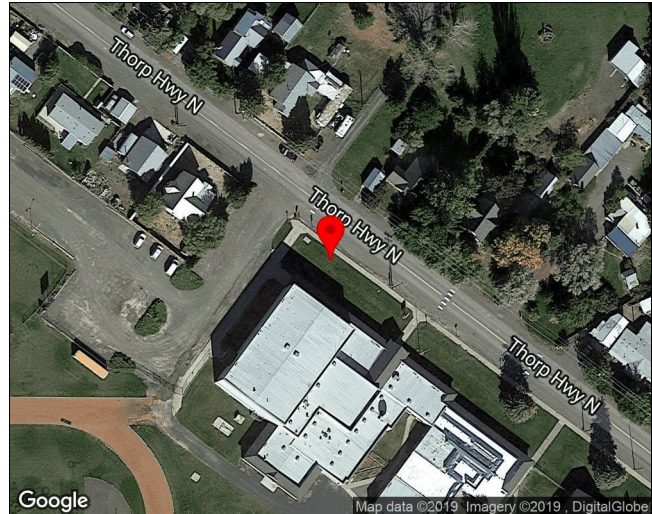
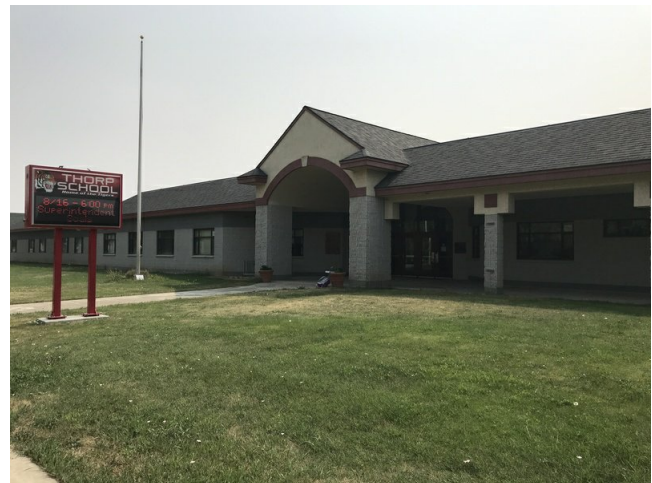
Thorp Senior High School was constructed in 1991 and is a rectangular building addition (approximately 170 ft x 124 ft) to the elementary school constructed in 1950. The high school/elementary school building shares the site with the 1935 brick Middle School building.

The high school building is wood frame with masonry veneer and the gym is reinforced masonry construction. The roof framing over the classroom/commons/office space is constructed with prefabricated wood roof trusses at 24" oc with 5/8" sheathing. The shear walls extend up to the roof. The gym roof framing is constructed with wood TJG trusses at 7'-9" oc with 2x10 at 24" oc joists and 5/8" sheathing (blocked at perimeter) supported on reinforced masonry walls. There is a wood frame second floor upper gym/mechanical space over the locker rooms. The upper gym/mechanical space is framed with metal joists.
